IOC / OdinAfrica / GLOSS

Technical Visit to Madagascar and Comoros

28 April to 10 May 2006

Frédéric SIMON
Surveyor
France

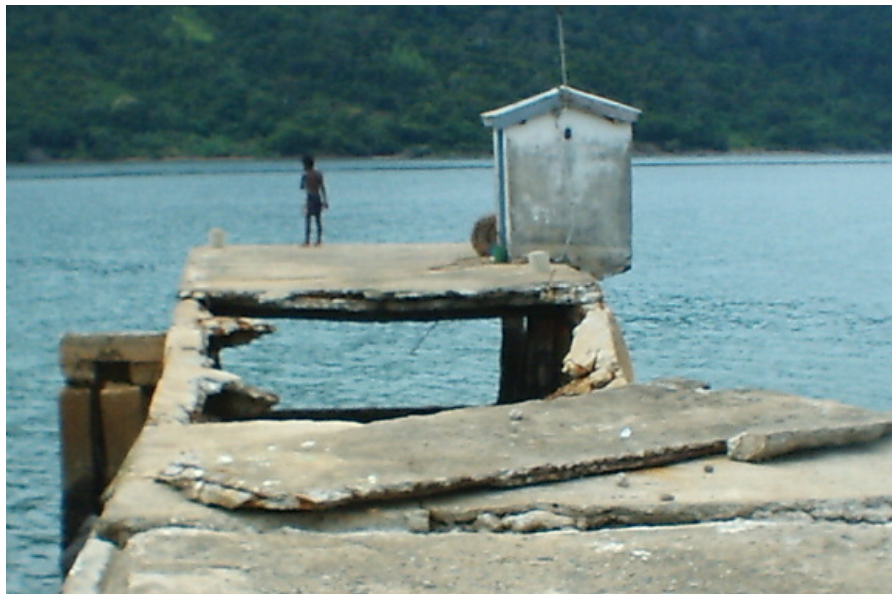
The tide gauge (floating sensor OTT R16 model) was operational until May 2003. After a series of problems, the tide gauge was stopped in June 2003. After looking at the tide records, it appears that the floating sensor was blocked in the stilling well tube. The bottom of the stilling well is now buried in muddy sand. The tide gauge equipment has been removed from the tide house. The power supply of the tide house has been cut and the tide pole has disappeared.

The pier was seriously damaged by the storm GAFILO in 2004. It must be rebuilt before any tide gauge installation. (See figure 1 below)

Figure 1 : Pier of CNRO (damaged by GAFILO storm) with the tide gauge hut

- the pier of CNRO must be rebuilt before the construction of a new tide house.
(This may be done this summer according to the director of CNRO)
- the power supply for the tide gauge must be maintained permanently. Solar panels are likely not sufficient to allow a tide gauge to function during several hours of power cut.

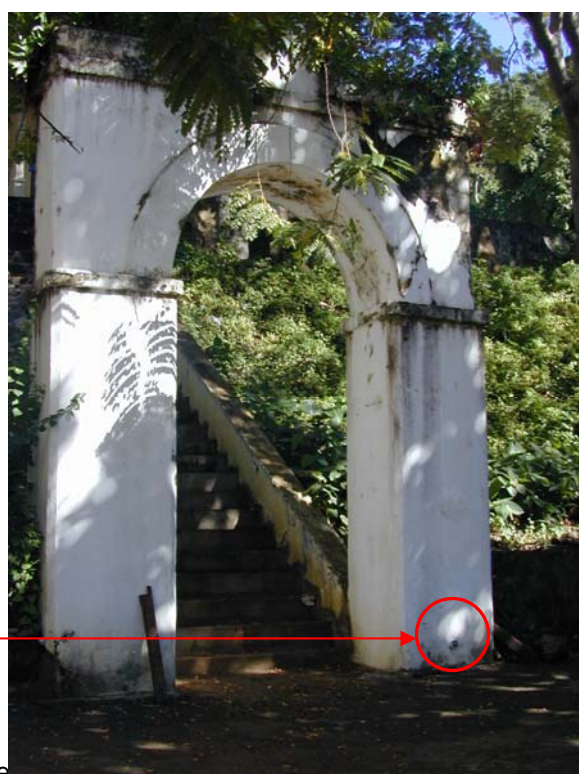
A tide bench mark has been located in the gate of the old entrance of CNRO. (See figure 2 at right)

It's a reliable TBM embedded by the French Hydrographic Office and can be used if needed.

The distance between the BM and the tide house is about 80 metres, and not too long for classic levelling.

Figure 2 : French Hydrographic Office BM

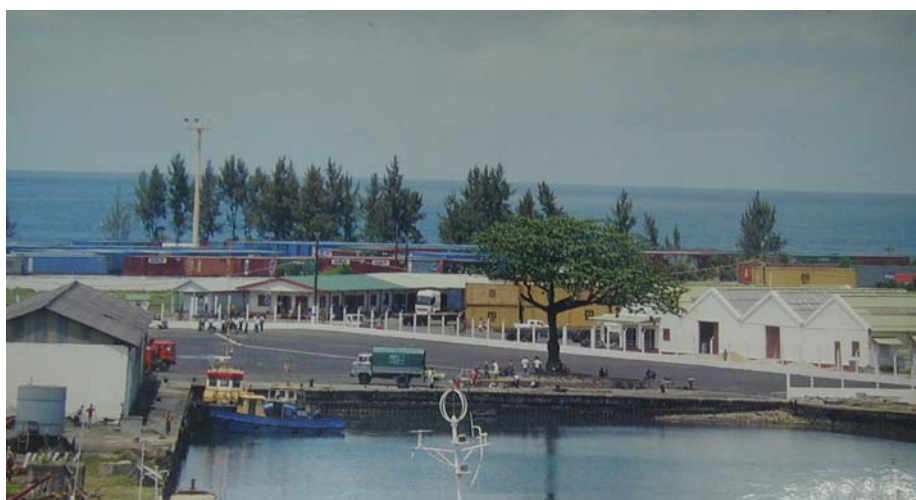
The old tide gauge installations (tide house, tide well and associated BM) have been destroyed and replaced by a fresh new car park in 2005 (see figure 3 below).

Figure 3 : The location of the old tide gauge is (approximately) just behind the van.

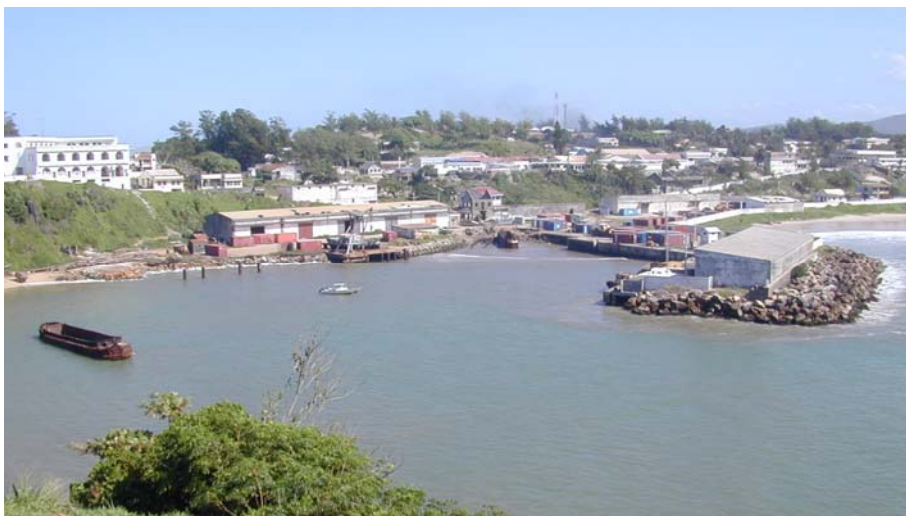
The port of Fort-Dauphin is very small (see figure 4). Merchant activities are practically nonexistent. The reasons are :

- the approaches of the port via Dauphine bay are extremely dangerous because of existence of many wrecks
- a steady (and sometimes heavy) swell sweeps across the harbour
- no industry in the vicinity of the town
- access roads to the town are in very bad conditions

A visit of the port installations was organized with the port master. There isn't any guard to ensure the security of the port. Any gate also. Many damaged containers, neglected within harbour, are used by poor people as habitation.

Figure 4 : View of the Fort-Dauphin port.

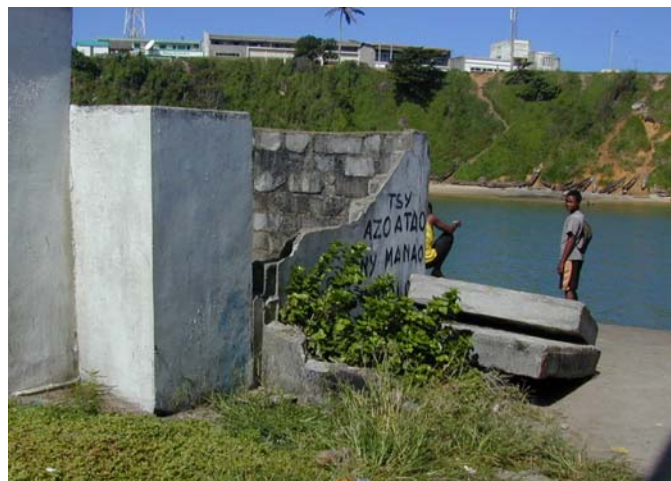
The National Institute of Geodesy and Cartography of Madagascar (FTM) and the Centre National des Recherches sur l'Environnement (CNRE) have installed a floating sensor tide gauge at the end of the main pier but the instrument stopped functioning correctly in 1998. In 2001, a big fissure (crack) appeared in the tide house wall and the equipment has been recovered. The tide gauge hut collapsed in 2002. It's difficult to find the exact location of the corresponding ruins without an accurate plan (see figure 5 below).

Figure 5 : Ruins (probably) of the old tide pier installed by CNRE and FTM (at the end of the main pier).

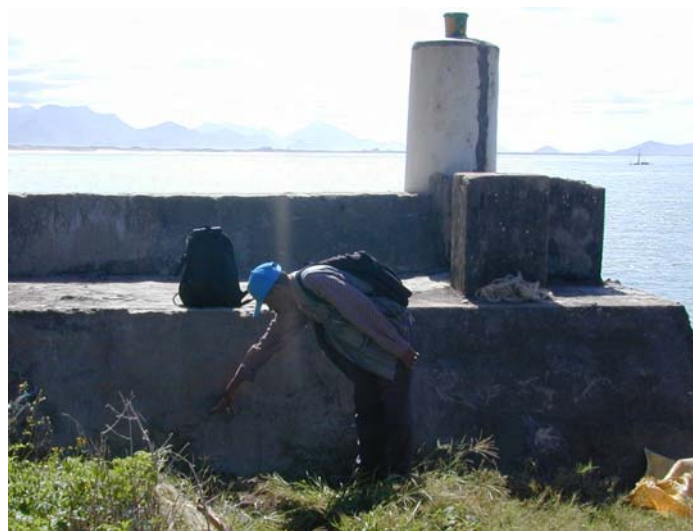
Figure 6 :

The BM installed by FTM has been located, embedded in the retaining wall of the port entrance lighthouse (see figure 6 below).

Bench Mark (rivet) embedded in the retained wall of the lighthouse.

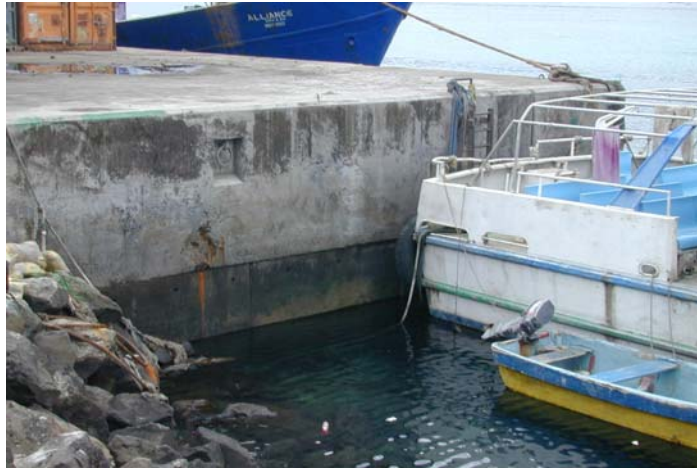
The north part of the new quay is sinking slowly in water. The south part doesn't offer enough space and enough water depth to install the tide house and the tide gauge well (see figure 7).

Figure 7 : South part of the “grand quai”

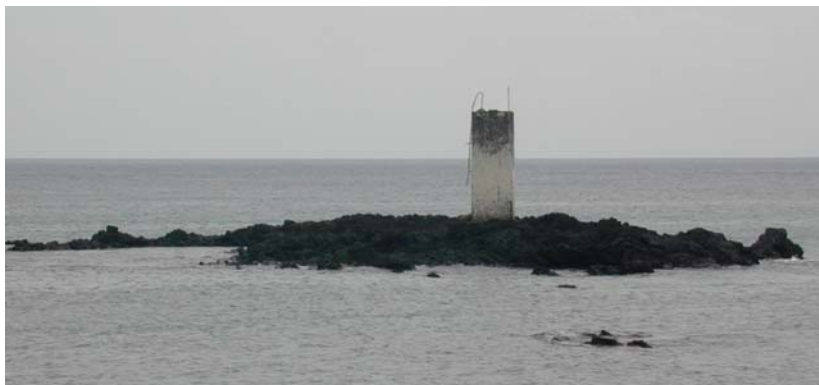
Only an old bench mark (1953) could still be present, embedded in the lighthouse building of the islet “Souadzou” (or “Souazou”) (see figure 8).

Figure 8 : Souadzou islet with ruins of the lighthouse.

The lighthouse is in ruins and the power supply is probably cut. Moreover water depths around the islet seem not to be sufficiently deep for a tide gauge installation. It was not possible for me to check the islet installation. Among the local contacts, nobody knew of the existence of the bench mark on the lighthouse.

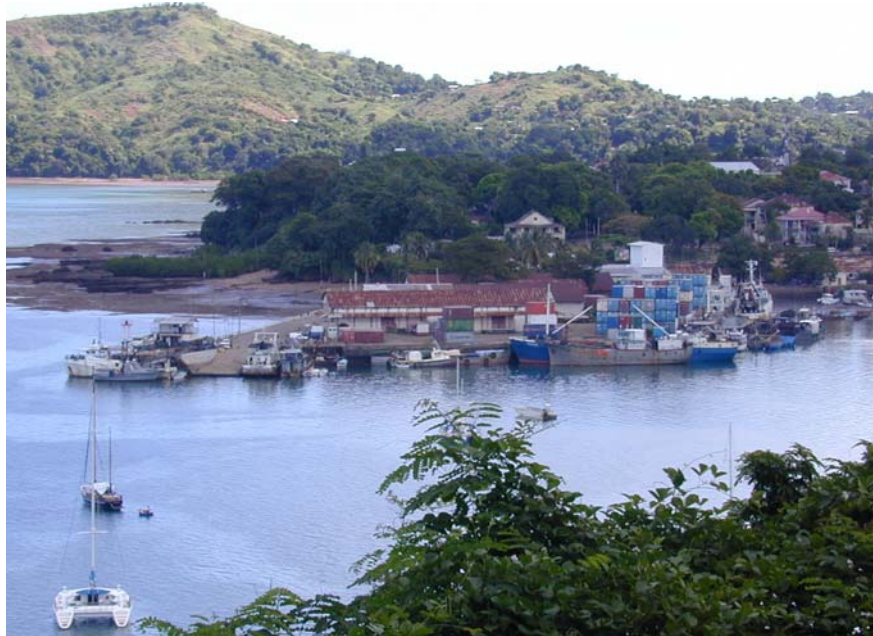
It was not possible to meet the port master. The port is very small and there is no suitable location for a new tide gauge (see appendix, figure 8). Security of the port is very limited.

Figure 9 : View of the port of Hell-Ville

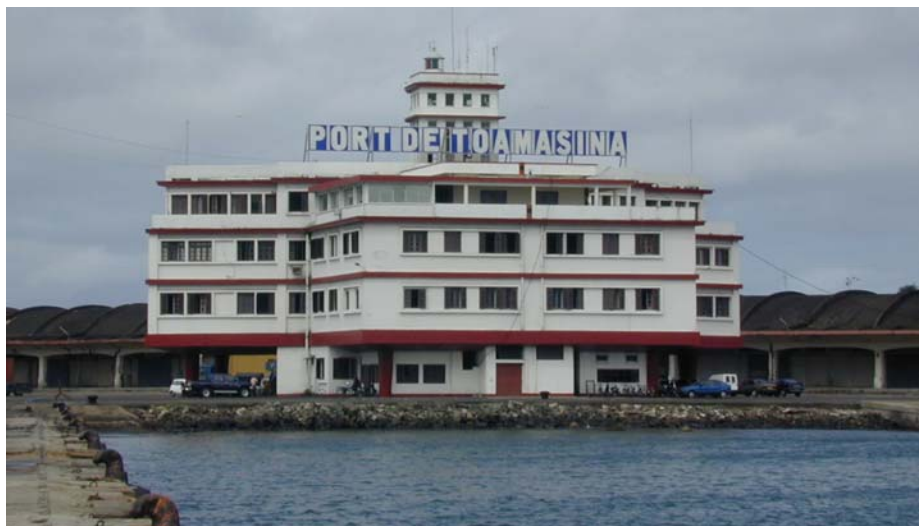
Figure 10 : View of the harbour office of Tamatave
(Could be a location for the new tide gauge ; easy power supply, in front of the pilot office, ... but no protection again waves (or swell) from wind and tide house to build).

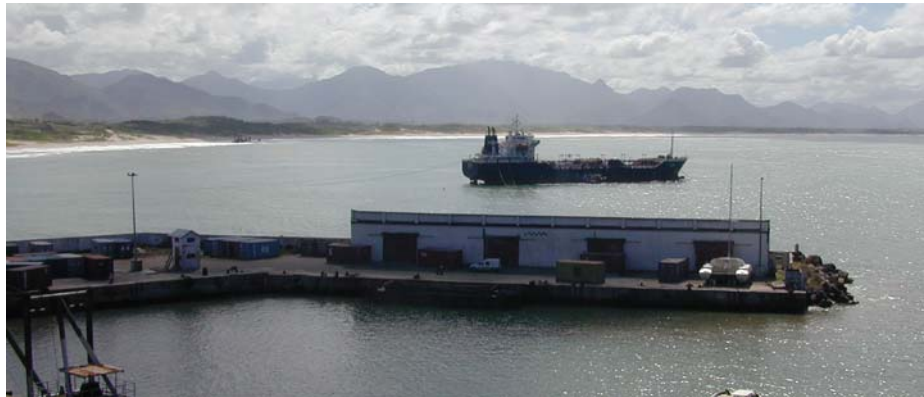
Figure 11 : View of the main pier of the port of Fort-Dauphin
